RTO / CONCENTRATOR REPAIRS

RTO UPGRADE RESTORES PERFORMANCE FOR ENGINE MANUFACTURER

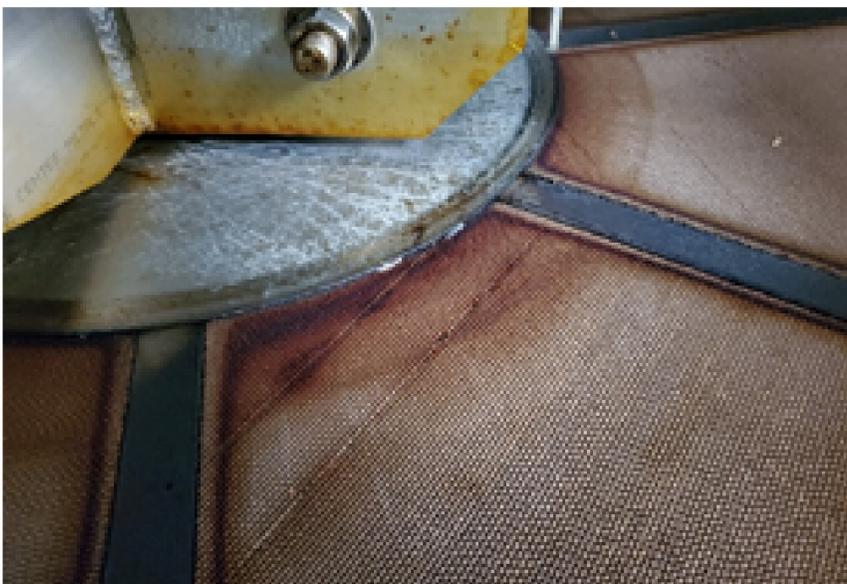
Above: Zeolite wheel surface coated with lacquer (yellow tint) from paint being drawn into the system.

- The U trap drain was positioned in a way that caused the line to plug, which in turn dampened the signal to the controller.
- Since the plugged transmitter was not reading accurate pressure at the inlet, the fan continued to increase in speed, topping out at a maximum of 60Hz. These unacceptably high fan speeds led to the high negative pressure exceeding 1 psi, too much for the aluminum walls of the Zeolite Concentrator to accommodate. This also allowed for the introduction of damaging aerosols, condensibles, and overspray from the paint booth into the concentrator, clogging the bags and dead-heading the fan. (Overspray issues at the inlet plenum further verified the fan had been pulling too hard from their process and contaminating the wheel.)

First, our team ensured the pressure transmitter and U trap drain were repositioned correctly and the ID tubing was resized. This addressed the underlying failure mode. However, due to the damage previously incurred, the Zeolite Wheel and mixing box dampers needed to be replaced and the baghouse damage required repair.

Upon delivery of the wheel and dampers, our team worked around the clock to complete the baghouse damage repairs, install the new wheel and mixing box dampers, and reset the RTO over a planned holiday shutdown consisting of just a few days.

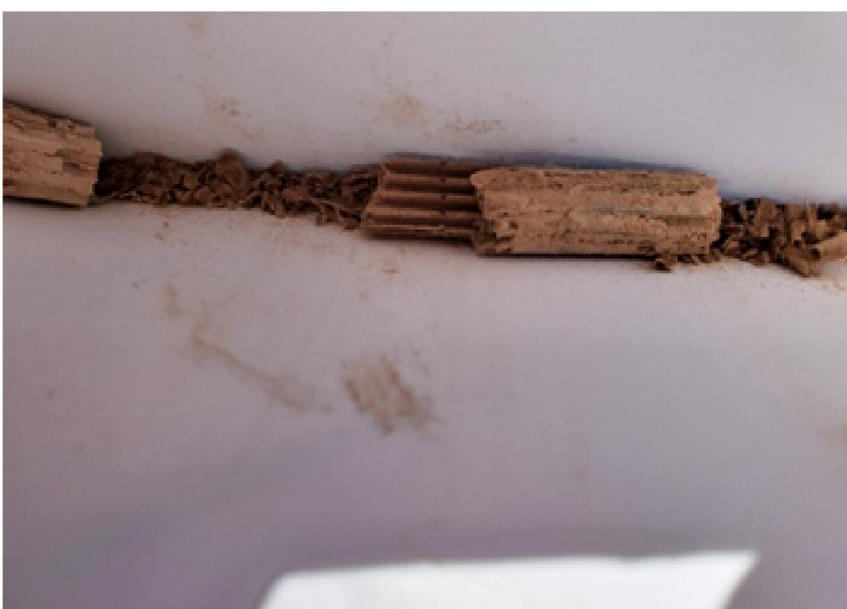
Below: Disintegrated core sample from wheel.

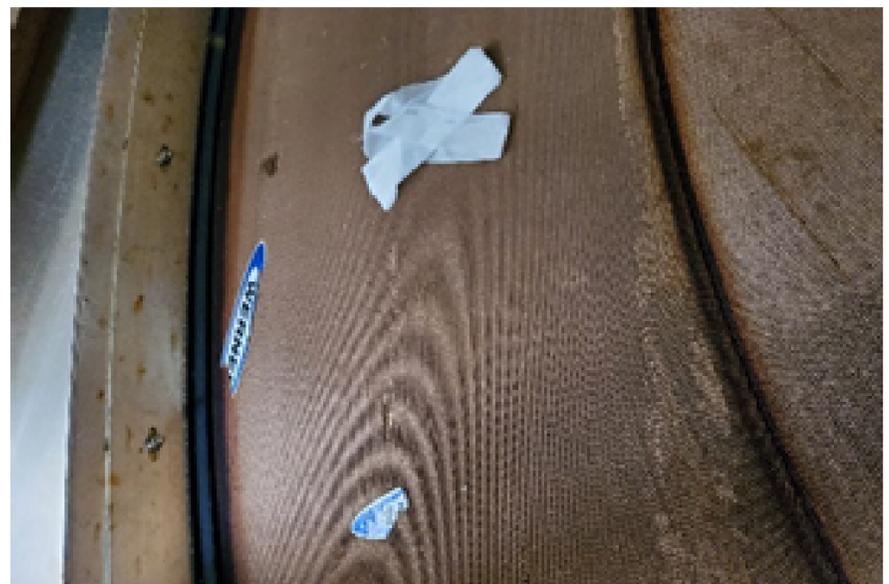
Above: Debris inside the concentrator

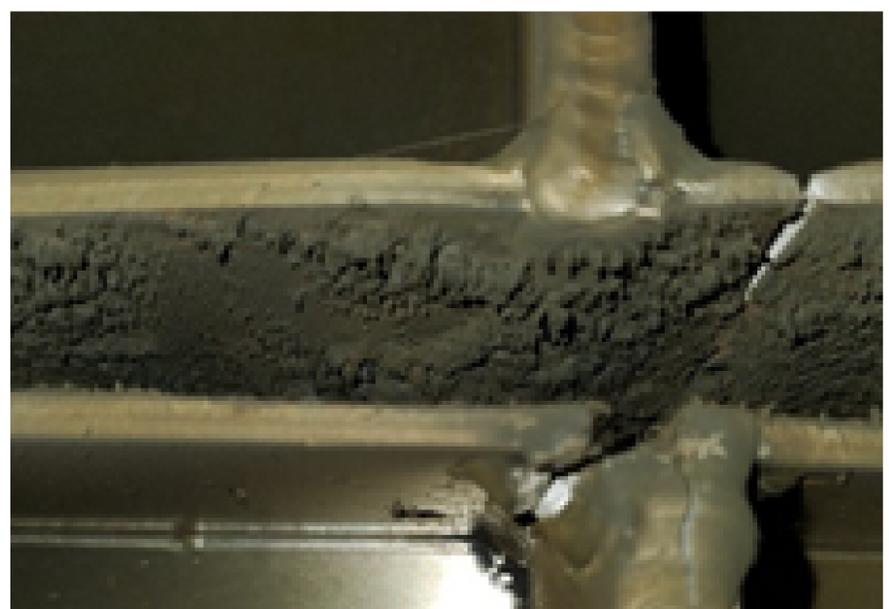
Below: Cracked baghouse filter frame
