POPPET VALVE PROJECT

POPPET VALVE ASSEMBLY PROJECT SOLVES RTO RELIABILITY ISSUES

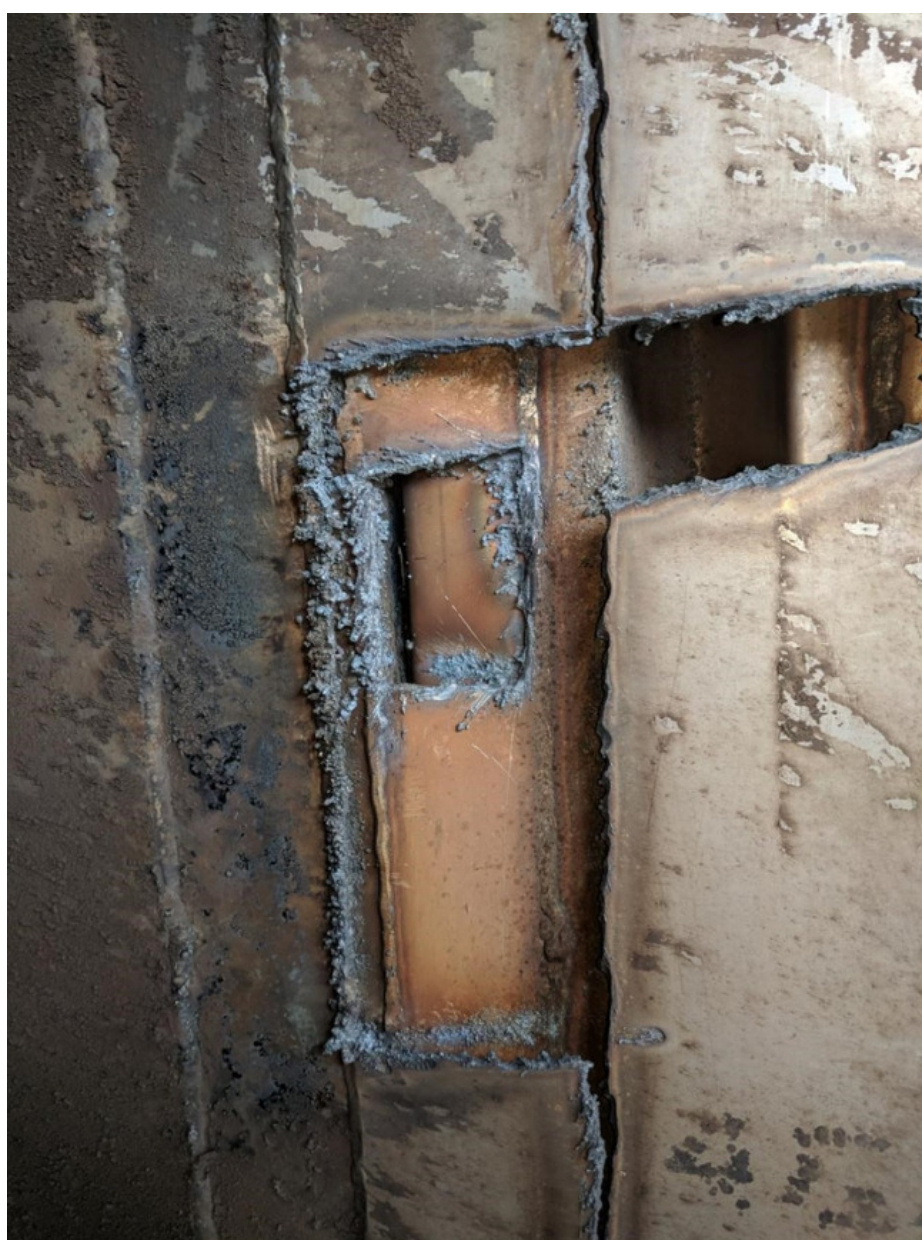
BEFORE: Expansion joint - 3 layers of liners

To resolve these issues, PolSys Services engineered and executed a variety of upgrades. We installed new high-quality poppet valve assemblies, interconnecting ductwork, and expansion joints below the RTO media beds. We also replaced the single-directional solenoids with high-quality, powered solenoids that rely on power to open and close vs. a spring. Low-quality actuators prone to reliability issues were replaced with high-quality, pneumatic actuators more immune to debris and moisture. Finally, we installed new cylinders, proximity switches, and wiring, along with more suitable gasketing. All work was completed without incurring any unplanned downtime.

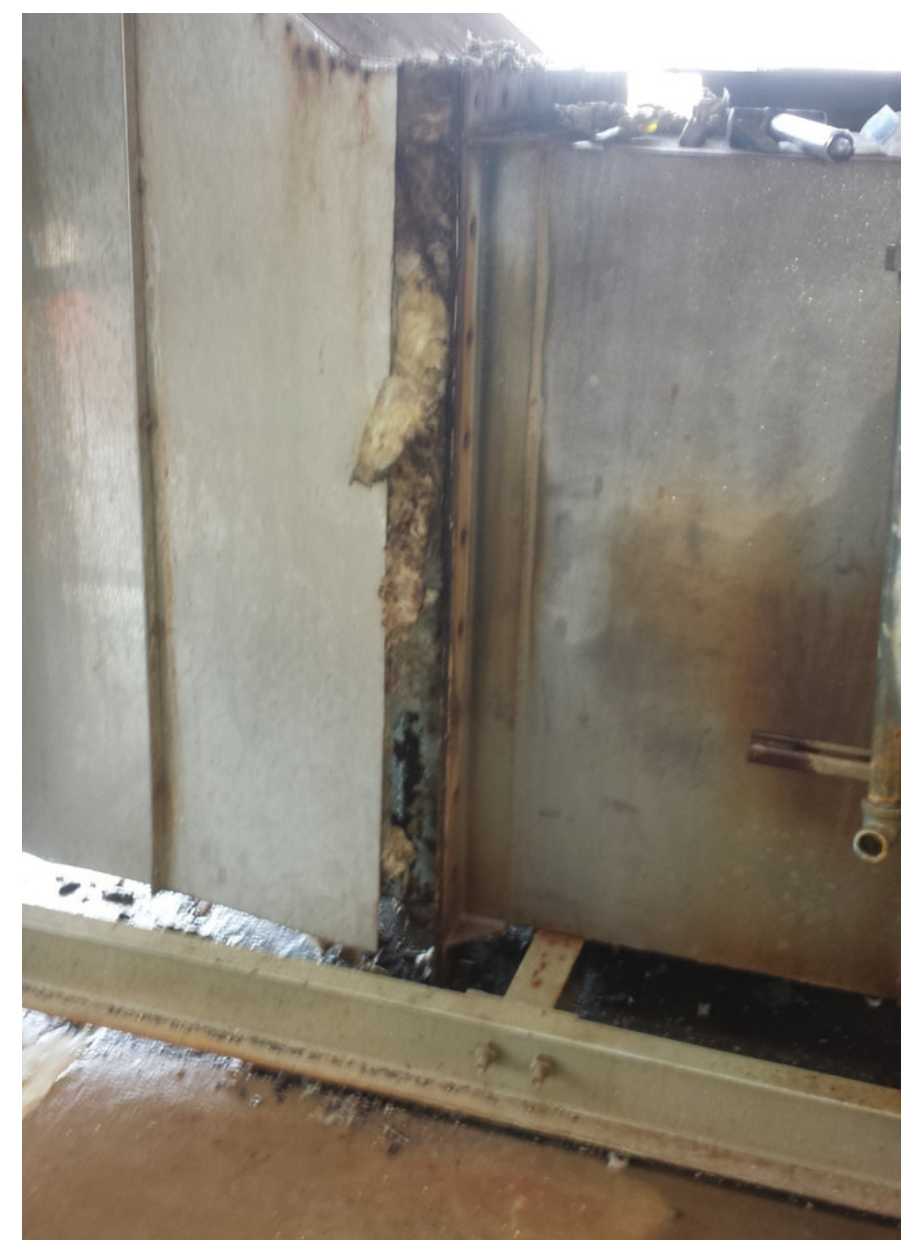
BEFORE: Connection at exhaust stack
