# MEDIA REPLACEMENT

## *MEDIA CHANGE RESTORES PLANT CAPACITY & IMPROVES FLOW*

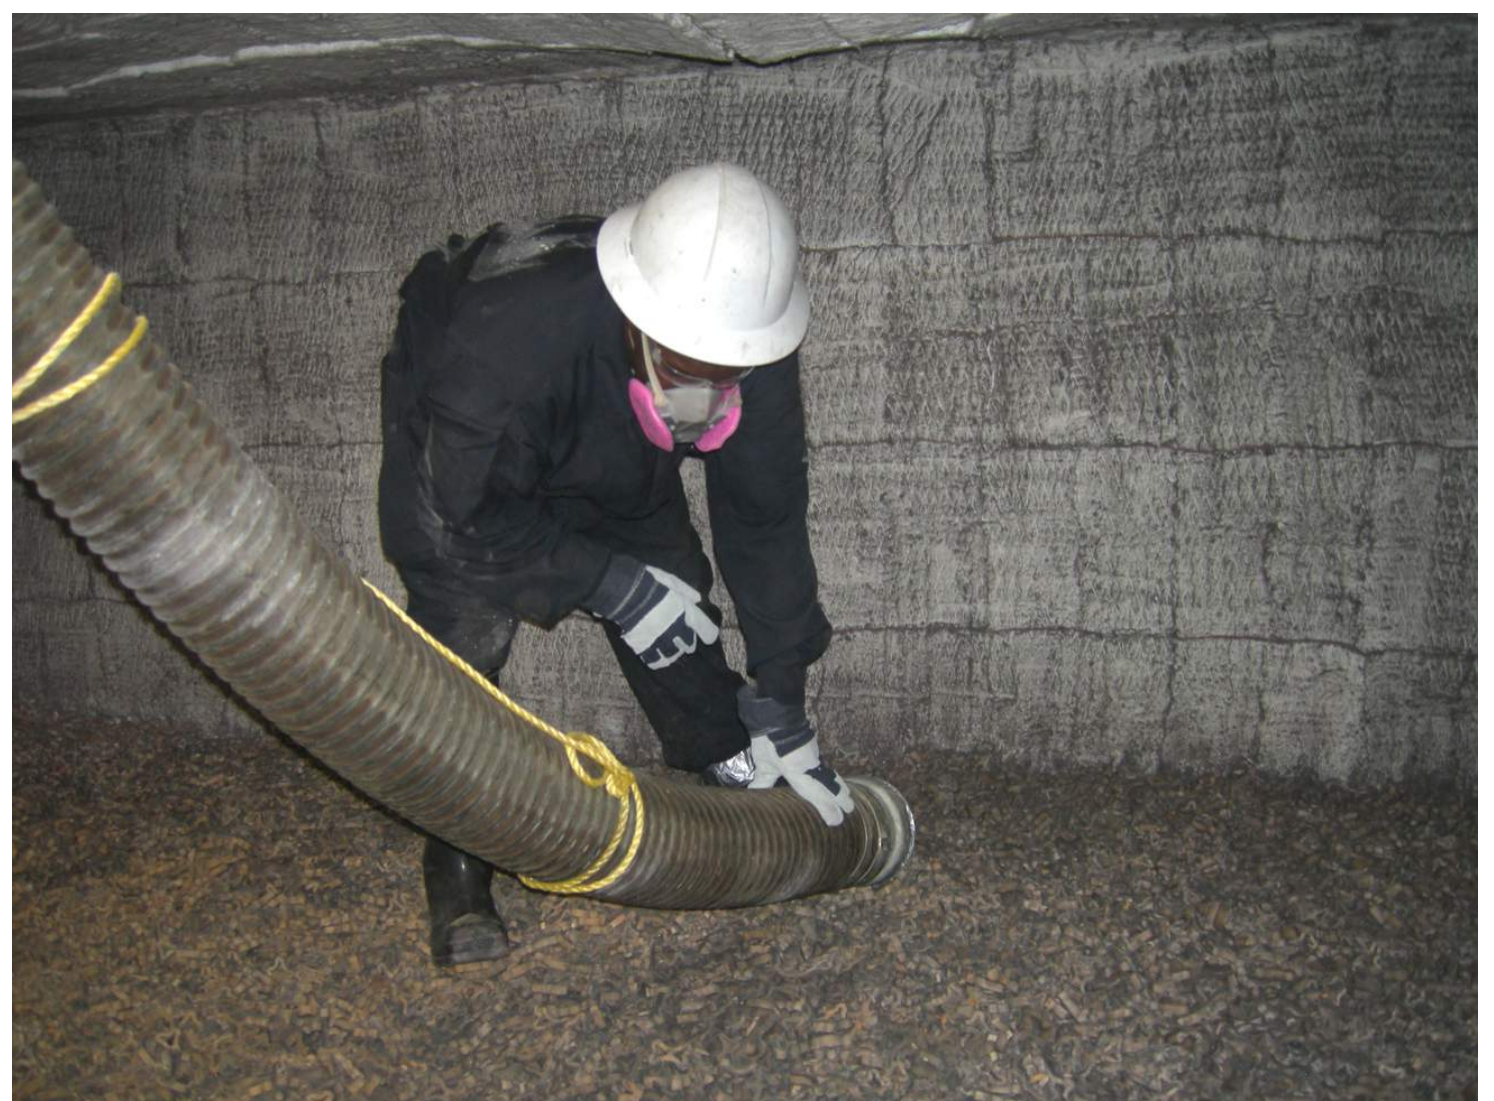
Structured media are designed to handle high performance and low pressure drops. However, introducing random saddles on the cold face subjected the incoming air stream to a high pressure drop layer before it interacted with the structured media. The impact of this random layer on the bottom is more severe than the layer at the top because the cold face is the lowest temperature-region of the media chamber bed, and is where most of the condensation and particulate clogging occurs. It is also the most difficult area to bake-out and clean. The top layer of random saddles is located near the very hot combustion chamber and therefore doesn't elicit the same concern. Our field service technicians resolved the air flow capacity issue by eliminating the bottom layer of random saddles and implementing five feet of a new highgrade structured media directly on the cold face. This new media has larger void openings and is more resistant to clogging. Upon removal of the media, shards of the fractured MLM media were

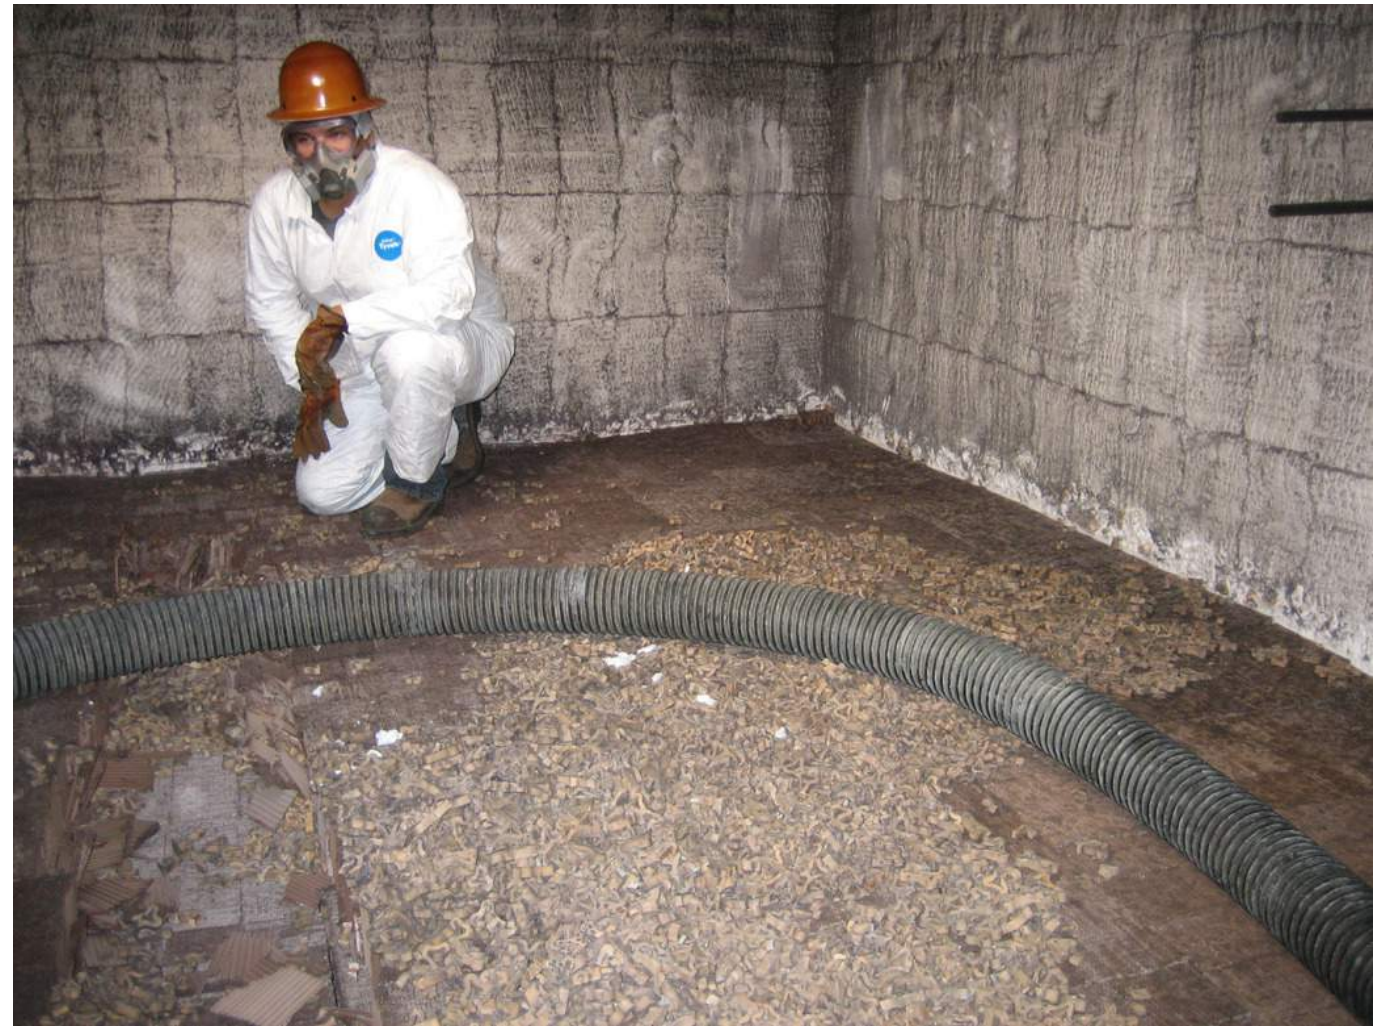
Aside from this major improvement, we worked around the clock in 12-hour shifts for the media removal and replacement to minimize downtime. Air flow through the RTO no longer

hinders the upstream manufacturing process, and the system has not displayed any of the other issues since this work was conducted.
