ROTARY RTO MEDIA CHANGE

OXIDIZER MEDIA REPLACEMENT RESTORES PERFORMANCE

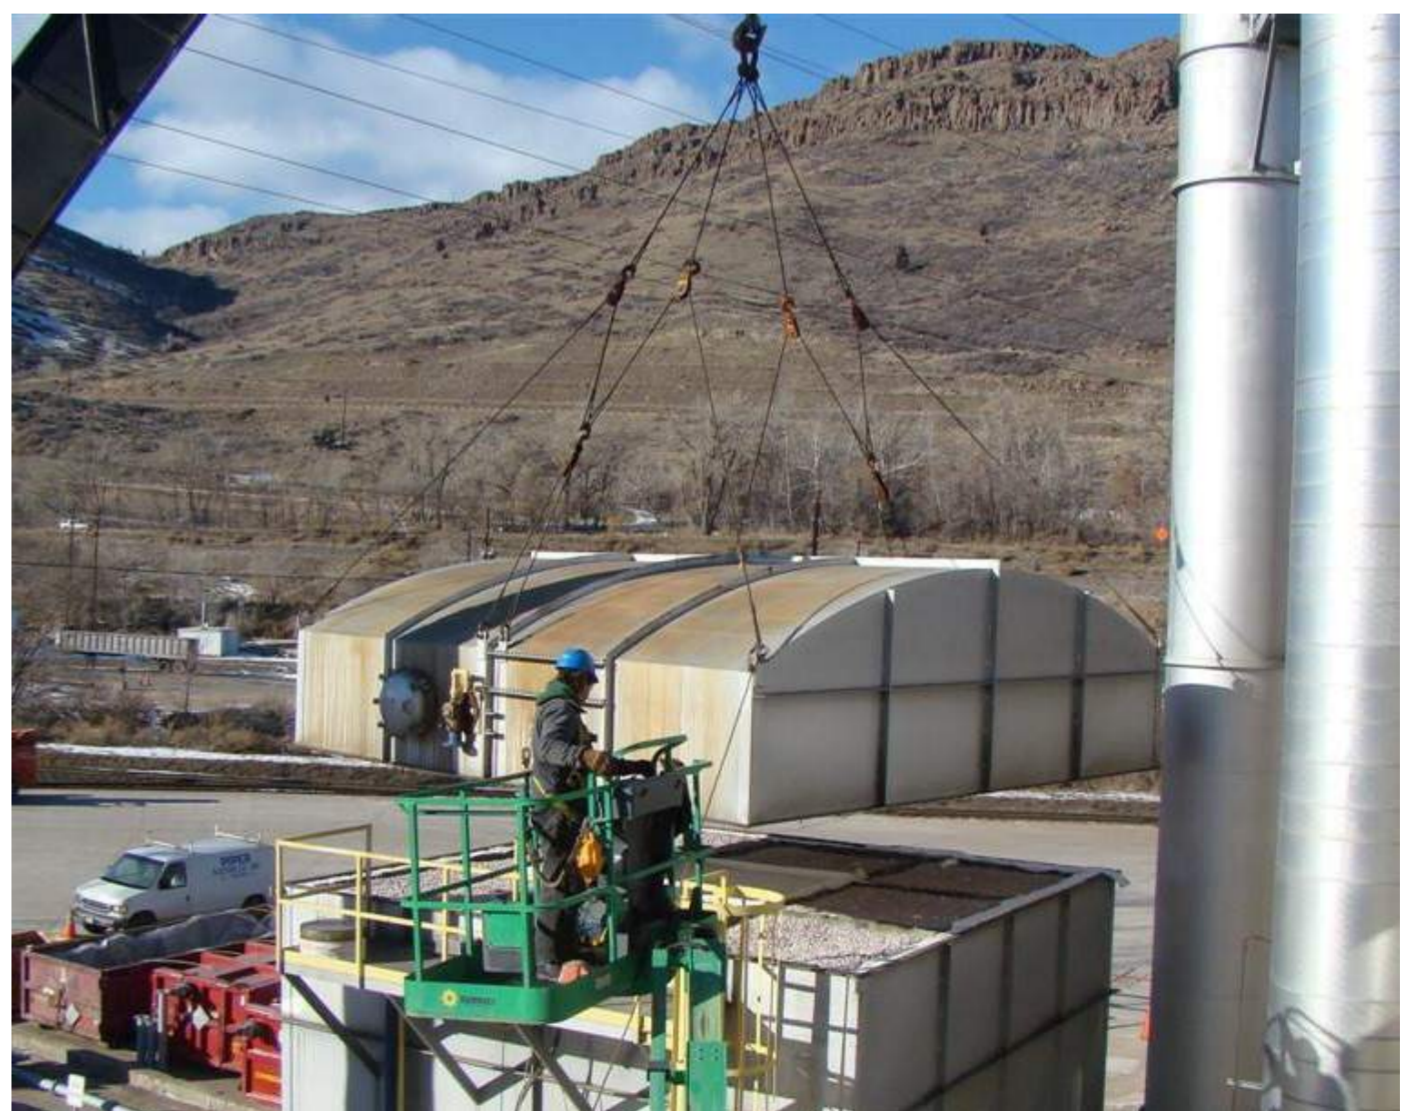
- The top of the RTO was cut off and lifted away using a crane in order to facilitate quicker removal of the existing ceramic media and to provide better access for necessary internal repairs.

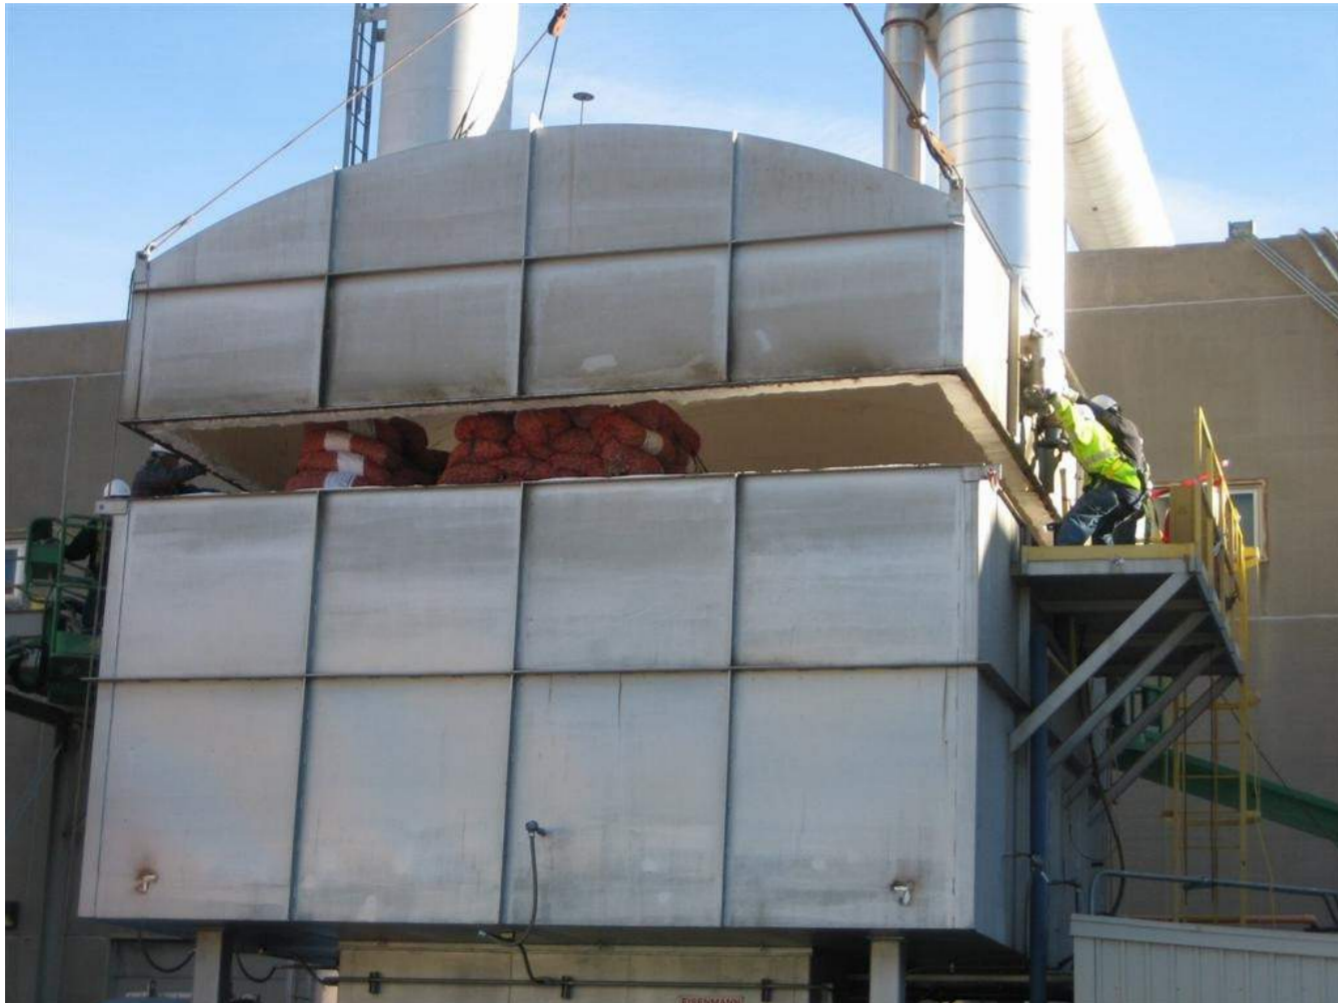
- The old stoneware was removed and stored in roll off bins until it could be analyzed and properly disposed.
- The existing support system and insulation were carefully examined for any signs of structural failure, degradation or media bypassing.

- Necessary repairs were made. Insulation was repacked around doors, openings, burners, etc.
- The new structured ceramic media was carefully and tightly repacked to the insulation in the chamber. Blocks of media were cut to the appropriate thickness to ensure a tight fit.
- The top was lifted and welded back in place.
- The site was cleaned, the refuse and old ceramic media were disposed, and the system was placed back in service.
