# TURNKEY RTO MEDIA CHANGE

## *NEW RTO MEDIA RESTORES PERFORMANCE FOR CAN MANUFACTURER*

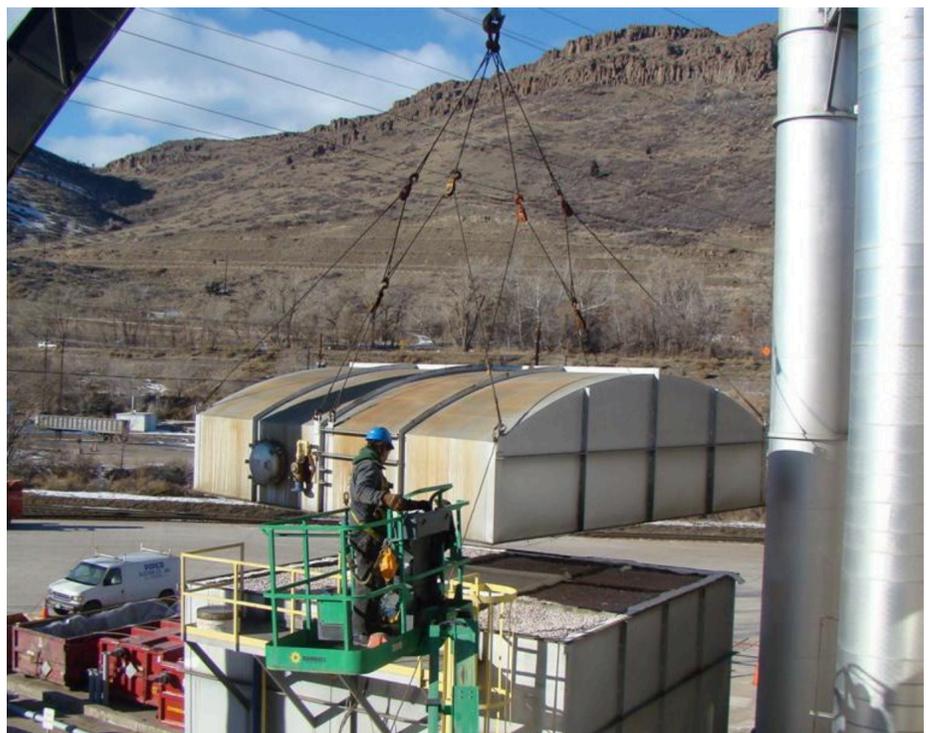
- The top of the RTO was cut off and lifted away using a crane in order to facilitate quicker removal of the existing ceramic media and to provide better access for necessary internal repairs.

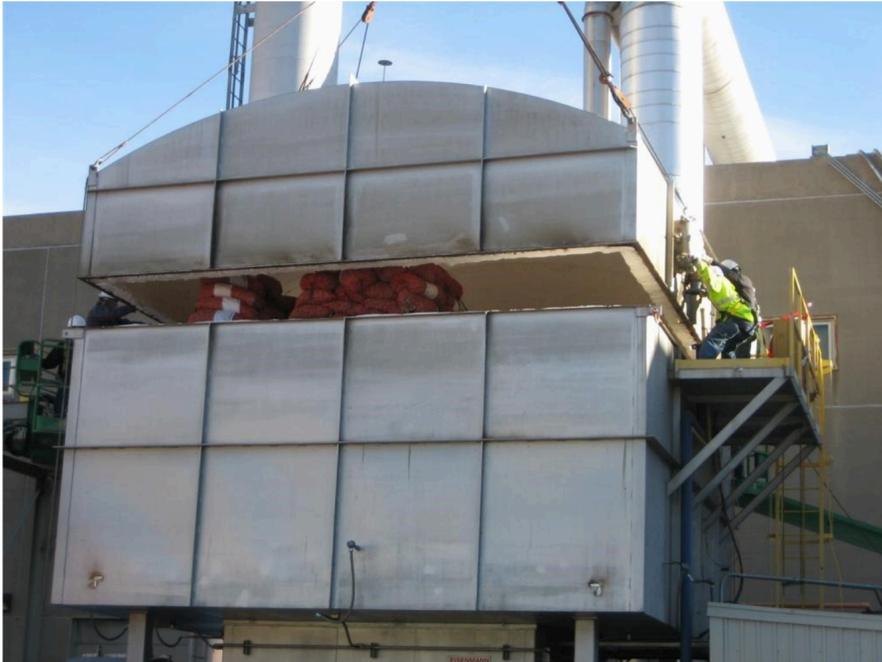
- The old stoneware was removed and stored in roll off bins until it could be analyzed and properly disposed.
- The existing support system and insulation were carefully examined for any signs of structural failure, degradation or media bypassing.

Necessary repairs were made. Insulation

- was repacked around doors, openings, burners, etc.
- The new structured ceramic media was carefully and tightly repacked to the insulation in the chamber. Blocks of media were cut to the appropriate thickness to ensure a tight fit.
- The top was lifted and welded back in place.
- The site was cleaned, the refuse and old ceramic media were disposed, and the system was placed back in service.
