# RTO HEAT EXCHANGER UPGRADES

**ACHIEVES ETO COMPLIANCE & PREVENTS COSTLY DOWNTIME**

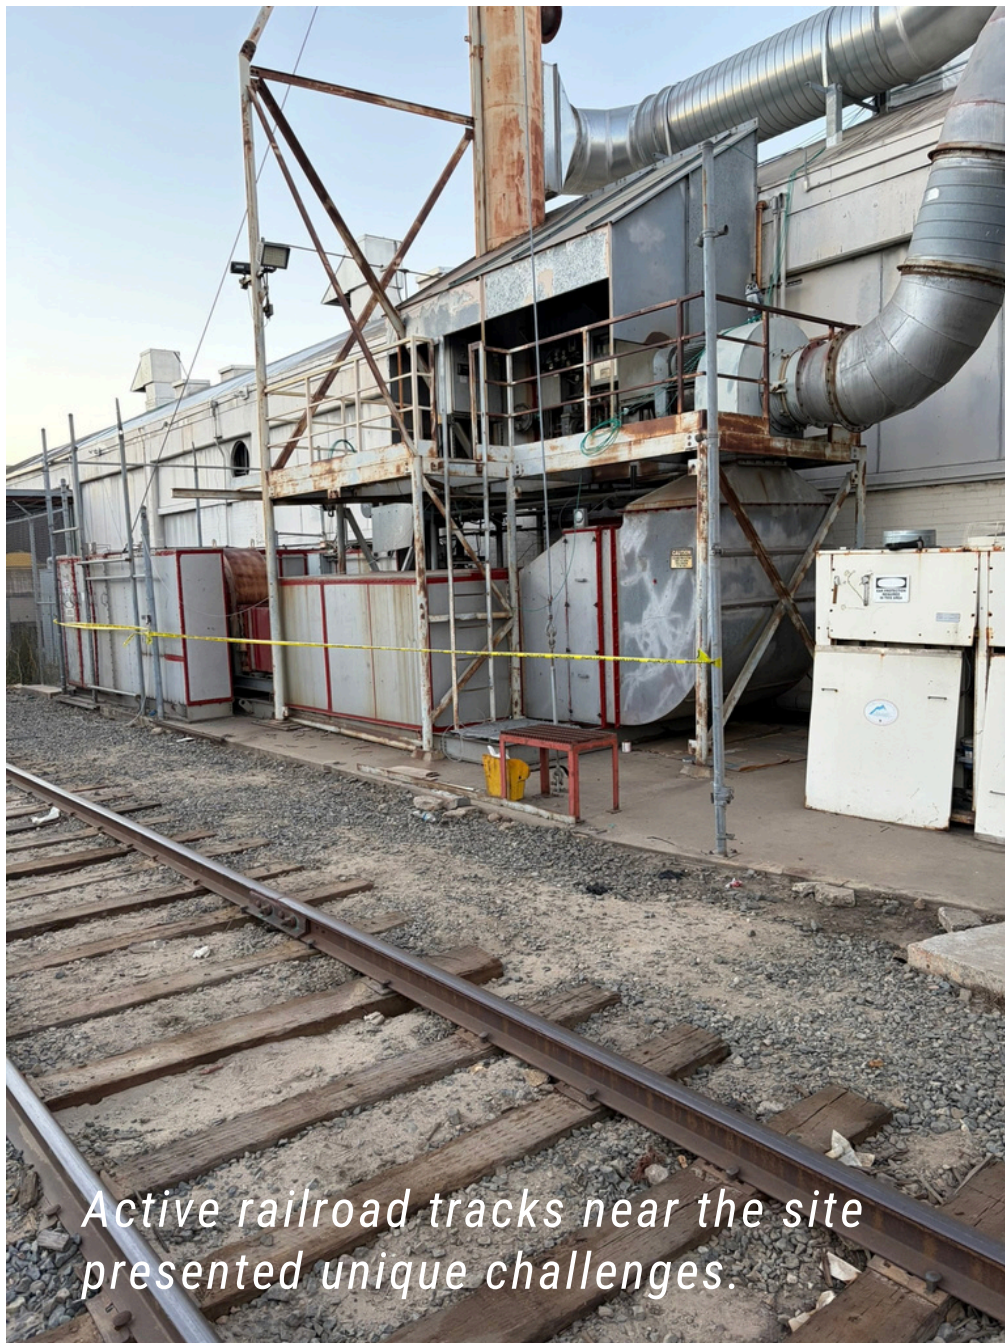
*Active railroad tracks near the site presented unique challenges.*

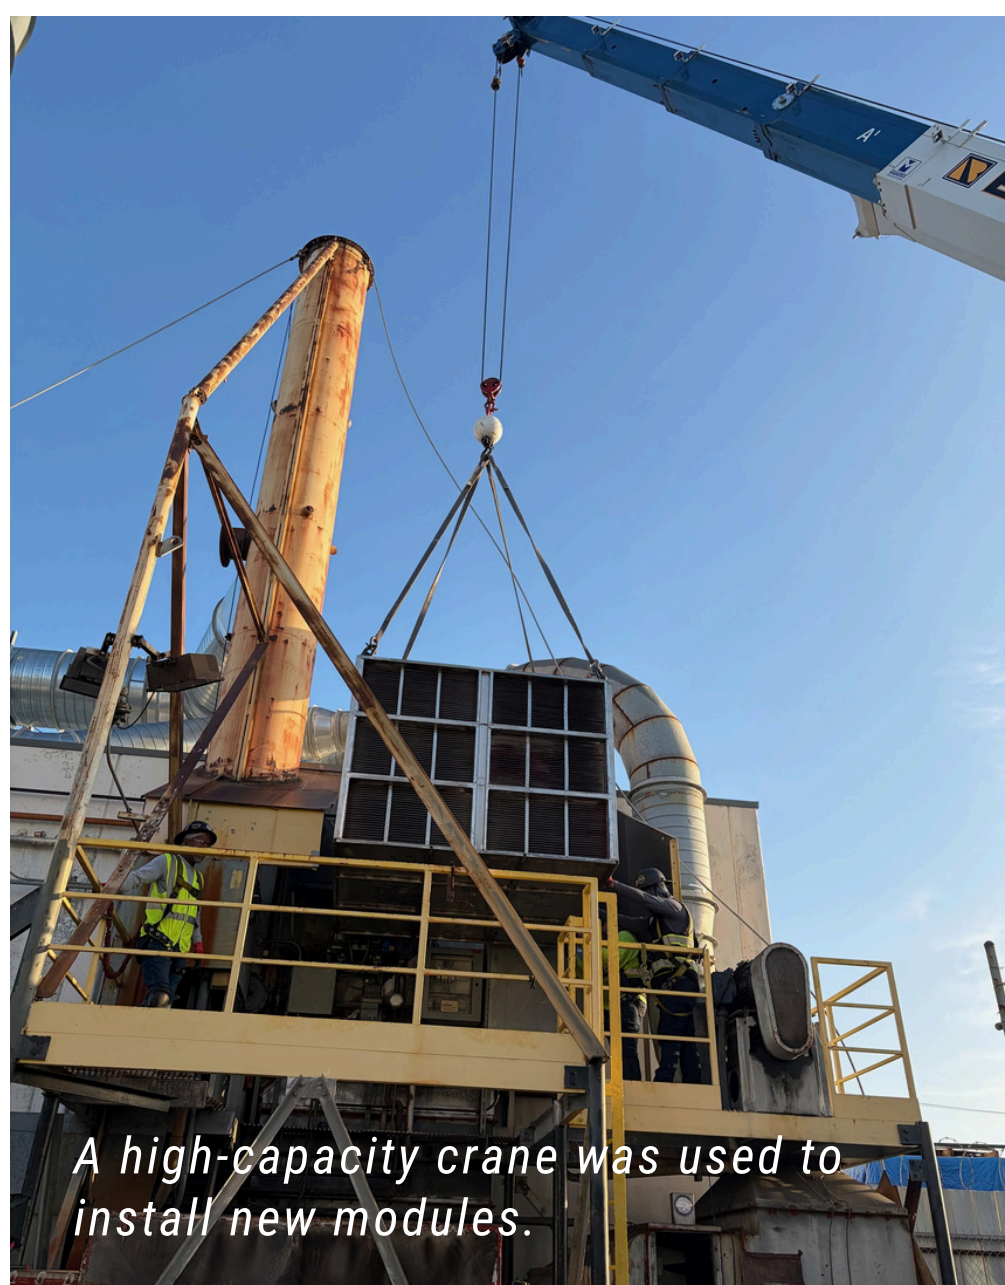
*A high-capacity crane was used to install new modules.*

After dismantling the top cladding and insulation, the team separated the RTV-sealed ducting connections and extracted the defective heat exchanger modules. Subsequently, the team safely installed two new, single-piece 13,000 lb. all-welded industrial plate-type air-to-air heat exchangers using a high-capacity crane securely positioned near the railway tracks.
